Manhole Inspection Summary

Manhole # S25GG_043MH

Location Address: **1813 BRUNT ST**

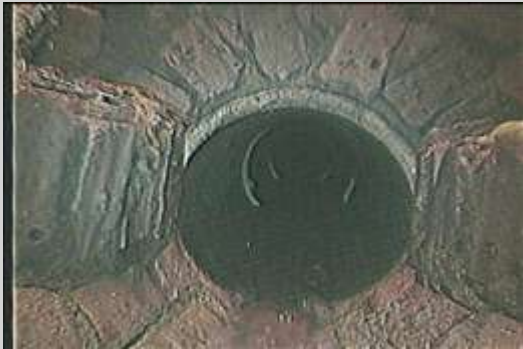
8 in. Circular Gravity Sewer Pipe Out @ 12 O'Clock

Pipe Material: **Clay** ☐ Pipe Lined

Invert Depth: **10.20** (ft.) Flow Characteristics: **Slow**

Deposits: ☒ None ☐ Mud ☐ Sludge ☐ Debris ☐ Grease

Infiltration: **None** Pipe Seal Cond: **Unknown**

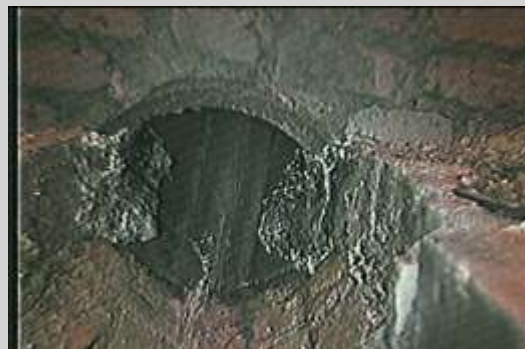
Drop In @ 3 O'Clock

Drop: **Outside** Rod and Bar

Angled: **Yes** Reading: **8.99** (ft.)

Inv Depth: **9.99** (ft.)

Drop Condition: **Open**

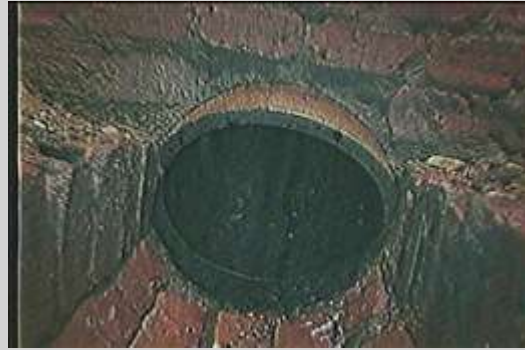
Drop In @ 6 O'Clock

Pipe Material: **Clay** ☐ Pipe Lined

Infiltration: **None** Pipe Seal Cond: **Unknown**

Drop Condition: **Open**
